TASMANIAN AVIATION HISTORICAL SOCIETY Incorporated
MYSTERIES OF AVIATION BEECH AIRCRAFT CORPORATION VH – WMD

Mysteries of Aviation – Beech Aircraft Corporation E55 VH-WMD

Author: W Dearing December 2020

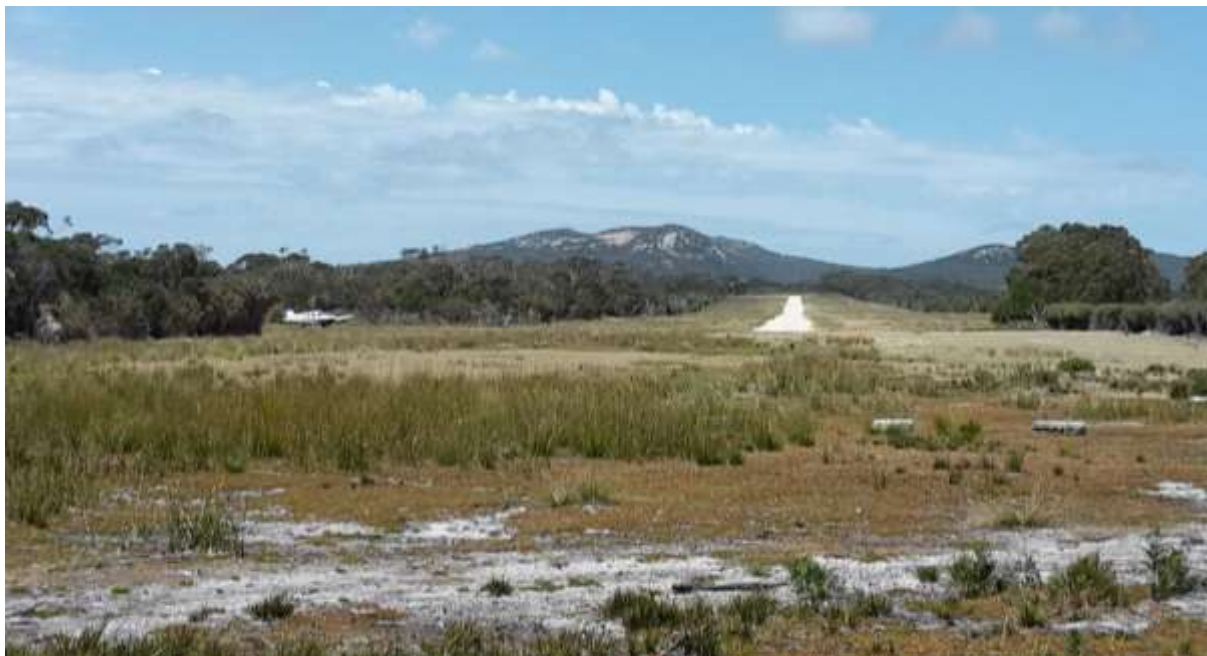
Killiecrankie airstrip Flinders Island, the proposed destination of VH-WMD. The airstrip is 1300 metres in length, sandy based and is aligned 09/27. It has no navigational aids.

The strip at Killiecrankie was equipped with a set of runway lights that could be activated by a series of coded radio transmissions from an aircraft VHF radio. The lights were capable of normal operation. When turned on, the lights remained on for approximately 30 minutes. The lights were not activated at or after the time of which the flash of light was seen.
